# Toolox

High Temperature Wear Resistance

### Toolox 44 – High Temperatures

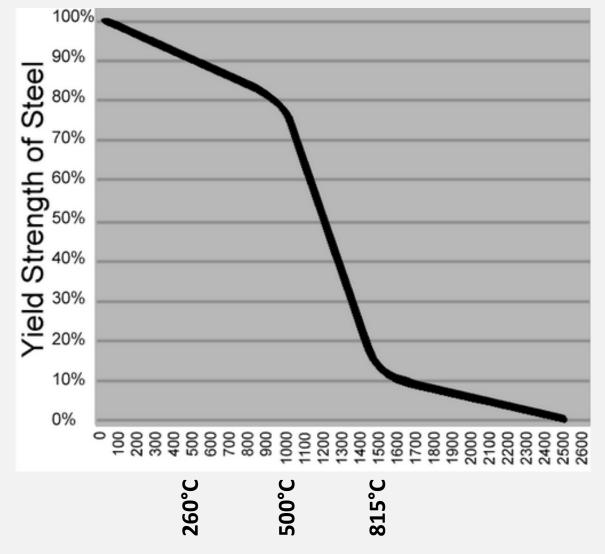
### Temperature x YS

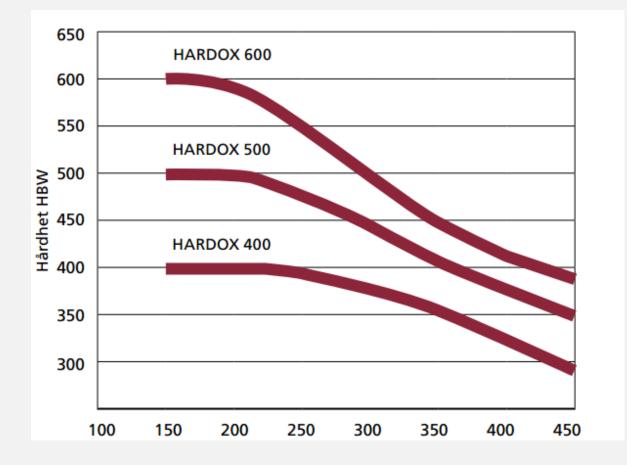
Hardness drops over 200-250°C

Retains 90% hardness up to 590°C

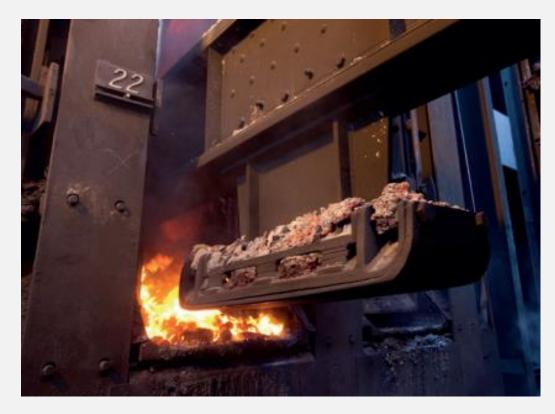
### Hardox 400 – 25 mm / lasts for 2 months

#### DESCRIPTION

Sliding shoe of pressure pole in coking plant. Pushes ready coke out of the blast furnace oven. Abrasion due to sliding on hot coke on top of a bed of heat resistant bricks.

Surrounding temperatures of approximately 1050 °C. Shoe is at temperatures of around 500 °C. Stays in oven 60 seconds per push.

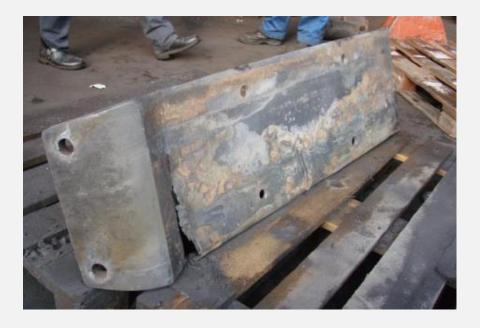
#### Problems

High temperature ruins hardness. After service life below 250 HB.

Expensive formatting. *Require extreme bending forces.*

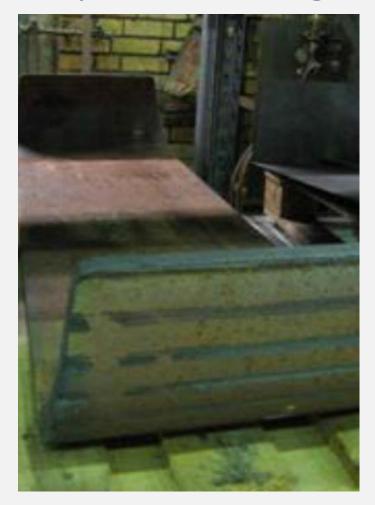
### 25 mm Hardox 400: 2 months Measured hardness on surface: ~ 230 HB 5x wear rate

Longer service life.

20 mm Toolox 44: 8 months

Will not back-temper at 500 °C.

Less maintenance, less downtime.

Lower formatting costs.

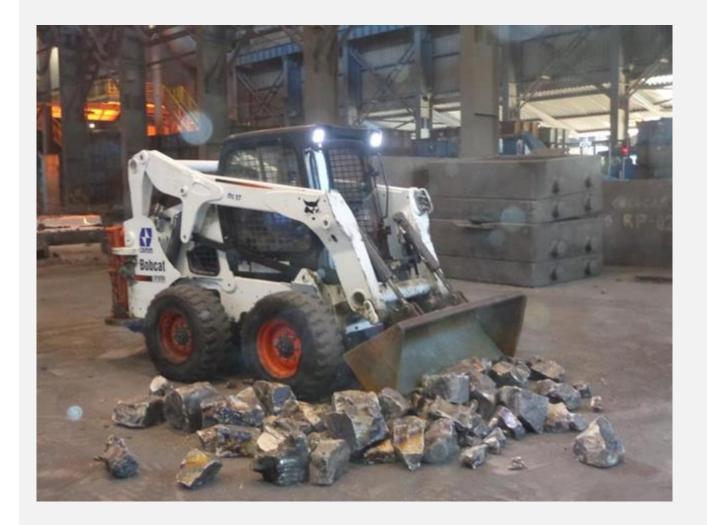
- Bucket used in to move hot slag (~350°C) from a Brazilian Fe-Nb production process.
- Before completely done with structural steel 350 Mpa YS and AR 400 on the front lip.
- Customer demand was to improve service life and reduce weight if possible.

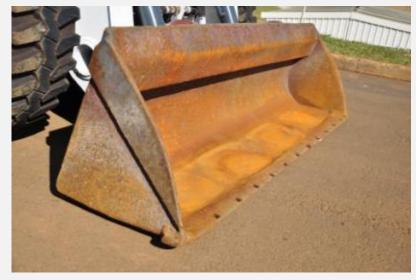
old

Material	A36/ AR400 front lip
Weight	364 kg
Service life	-320 hrs (average) -530 hrs (best one)
Production Cost (Ref)	1

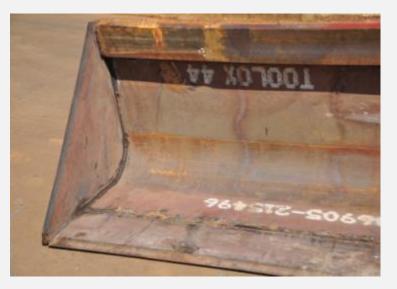
#### new

Material	Weldox 700/Toolox 44
Weight	274 kg
Service life	1655 hrs
Production Cost (Ref)	1,40

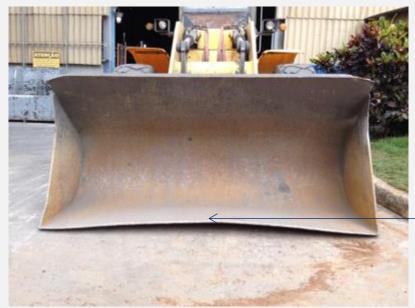
### Deformation of front lip

-Cracks in the structure after ~200hrs -severe wear of the front lip

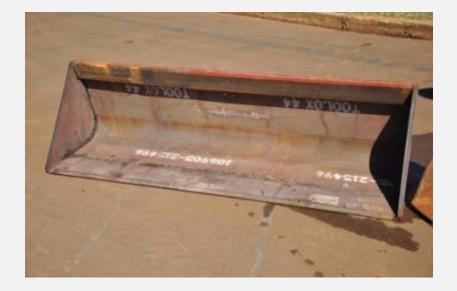
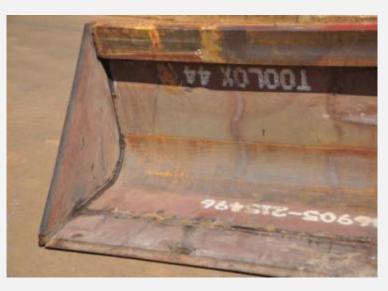
### • Weight: 274 Kg

- Weight reduction : 24%
- Service life: 1655 h

Advantage	%
Weight reduction	24,3
Working hours cost reduction	- 53,3
Improved service life	188

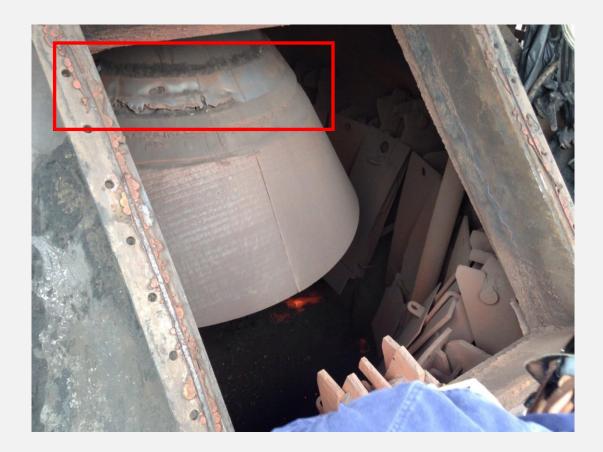
- Cone used to load iron ore into the blast furnace
- Temperature reaches 300 C.

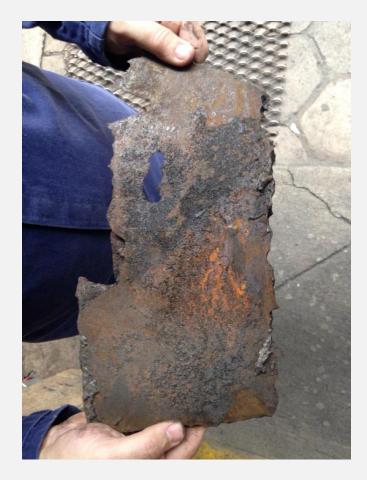
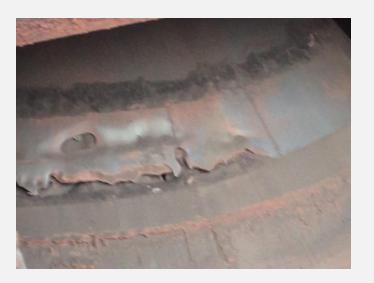
- Old one made with Hardox 500
- It lasts for 45 days

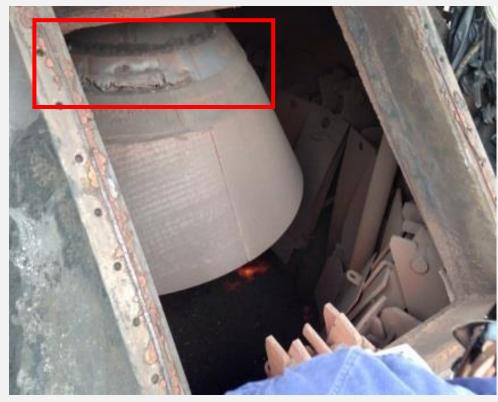
Hardox 500 after 60 days

Increasing lifetime more than 3x

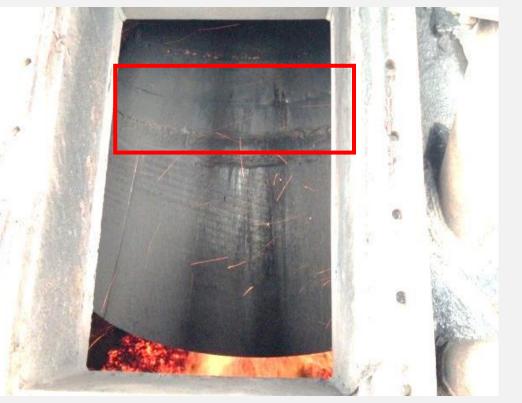
Toolox 44 after 60 days

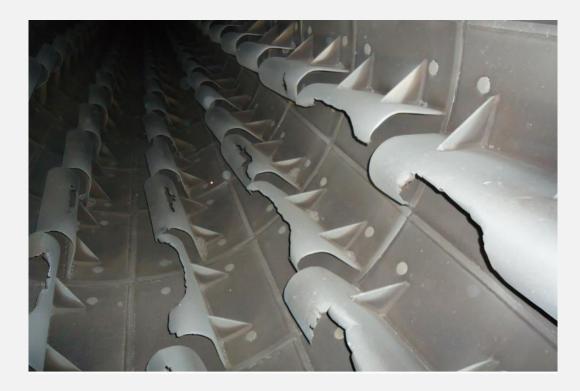
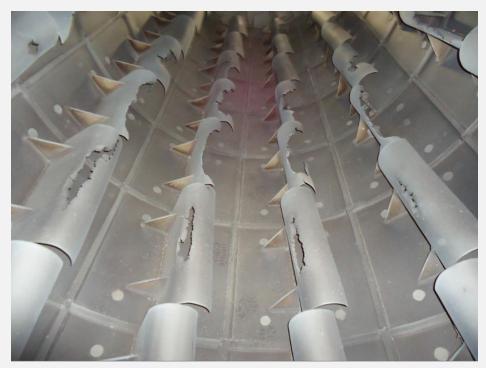
Pictures taken after 18 months of usage

- Old one made with Hardox 500
- Wear Problems at work temperature of 350 400 °C
- Hardox 500 lasts for less than 18 months

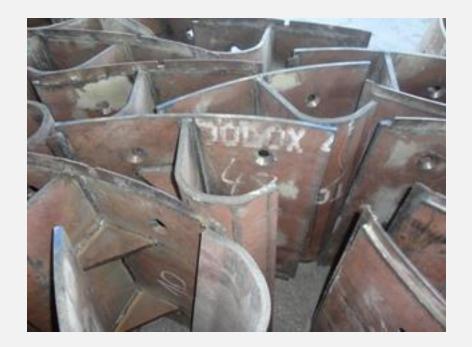
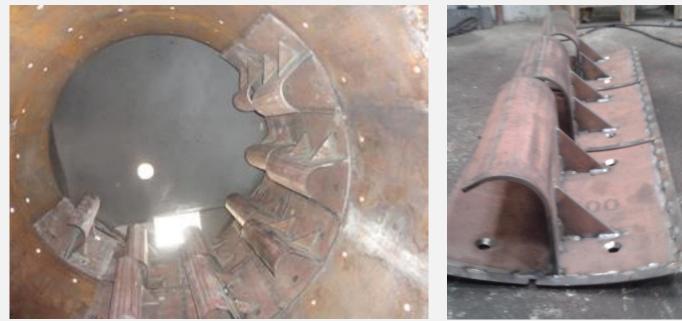
New drum made with Toolox 44

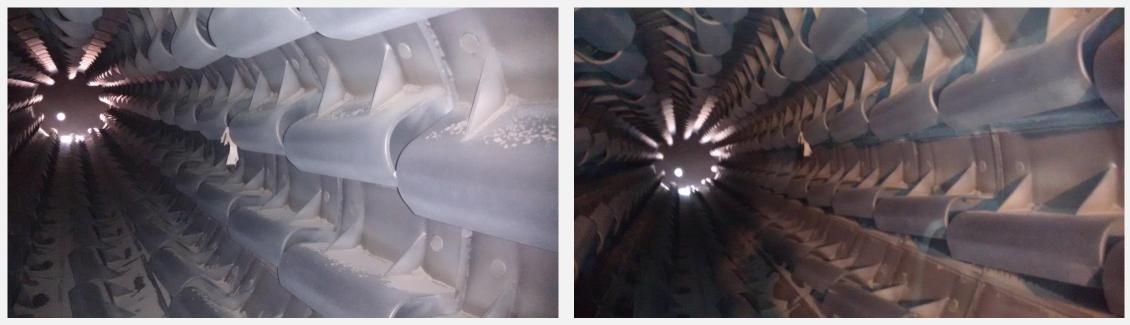
Pictures taken after 18 months of usage

- Checked with 18 months of usage and no damages were verified.
- Customer is happy and expect to double the lifetime of the parts.
- Less maintenance and downtime

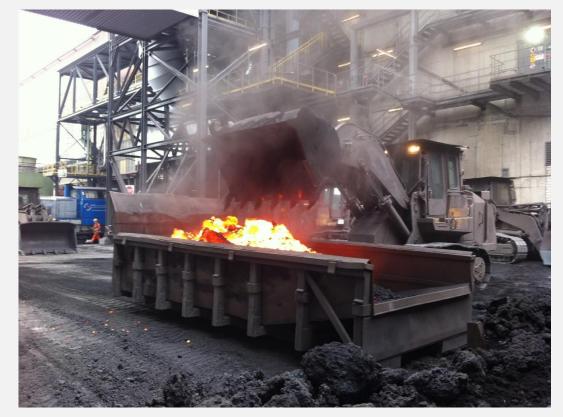
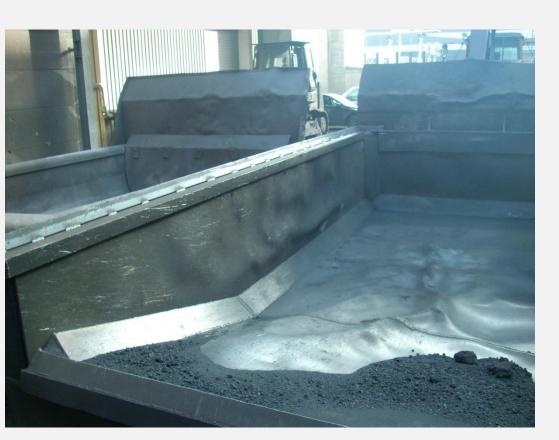
- Old Solution after 6 months, using standard steel
- Used to transport Slag from steel mills

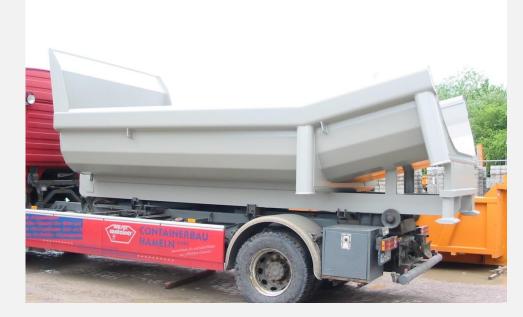
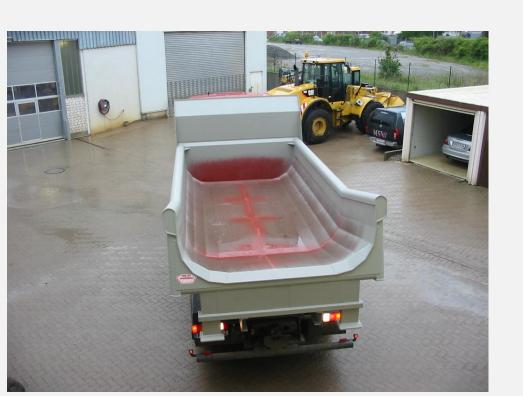
- New solution using Toolox 44 8 mm
- Reinforcements use Strenx 700 MC

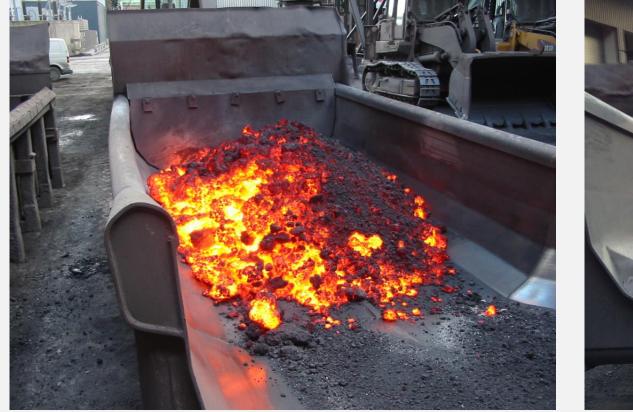
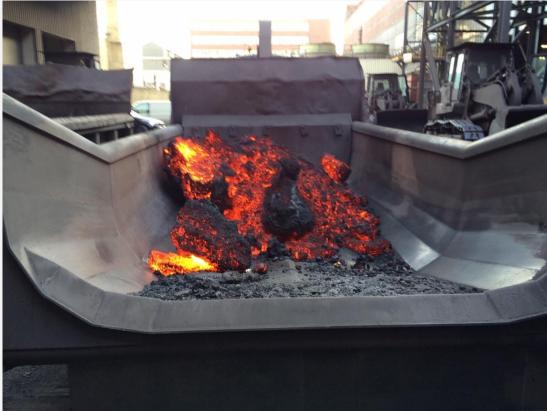
New Solution after 7 months of usage

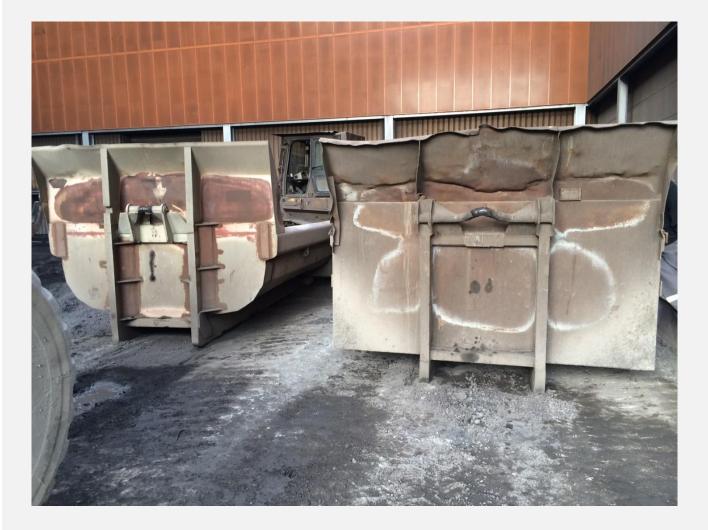
Old Solution x New Solution
